# Manhole Inspection Summary

Manhole # S51O\_\_050MH

Insp Date: **4/23/08 11:10 AM**

**Location** Address: **lakewood avenue**

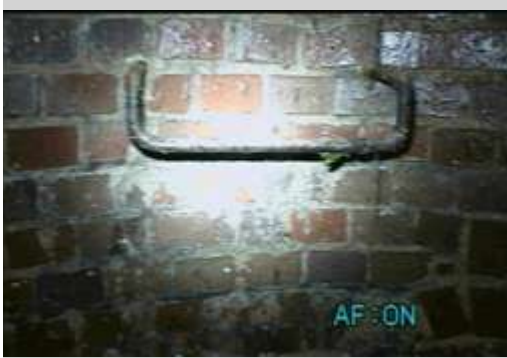
Defect 1

Count: **9** Missing: **0** ☒ **Corroded**

steps

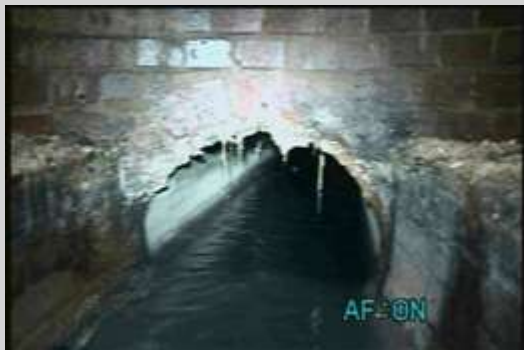
12 O'Clock Outflow

8 in. Circular Gravity Sewer  
Pipe Out @ 12 O'Clock

Pipe Material: **Clay** ☐ Pipe Lined

Invert Depth: **15.30** (ft.) Flow Characteristics: **Fast**

Infiltration: **None** Pipe Seal Cond: **Unknown**

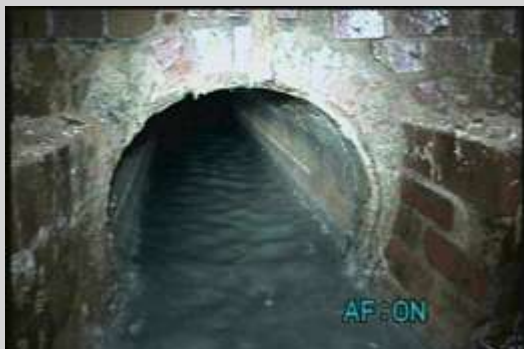
6 O'Clock Inflow

8 in. Circular Gravity Sewer  
Pipe In @ 6 O'Clock

Pipe Material: **Clay** ☐ Pipe Lined

Invert Depth: **15.00** (ft.) Flow Characteristics: **Fast**

Infiltration: **None** Pipe Seal Cond: **Unknown**

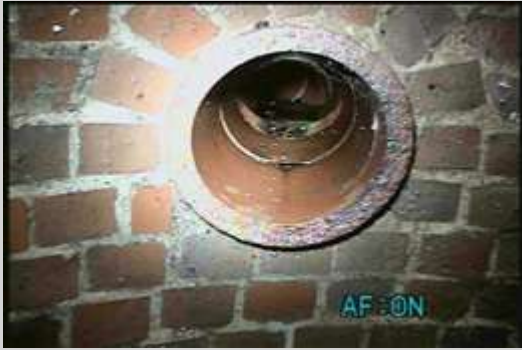
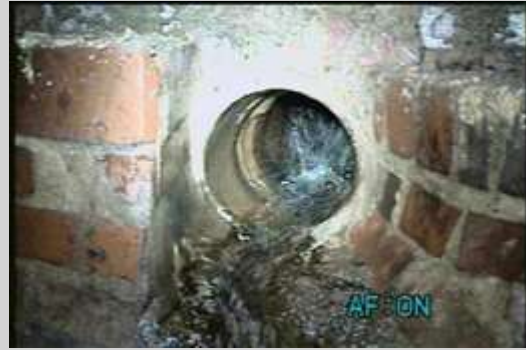
9 O'Clock Inflow

Pipe In @ 9 O'Clock

Drop In @ 9 O'Clock

Drop: **Outside Direct**

Drop Condition: **Open**
